## TEST REPORT

TEST REPORT			
Sample / Report No.	ELD3170052021	Page 1 of 5	
Name and Address of Customer	Avery Instrument Unit 8, 23/F, Laurels Industrial Centre, 32 Tai Yau Street, San Po Kong, Kowloon, Hong Kong		
Product Description	Pressure Transducer		
Sample Qty.	01	Date of Receipt	13/11/2021
Model Number	AV300P300A4L3Q013	Start Date of Analysis	13/11/2021
Name of Manufacturer & Address:	Avery Instrument Unit 8, 23/F, Laurels Industrial Centre, 32 Tai Yau Street, San Po Kong, Kowloon, Hong Kong	End Date of Analysis	27/11/2021
Test Standard	Shock Test As Per IEC 60068-2-27, Sine Vibration Test as per IEC 60068-2-6, Random Vibration Test as per IEC 60068-2-64	Report Issue Date	29/11/2021
Sample received condition	<input checked="" type="checkbox"/> Good <input type="checkbox"/> Others		
Test laboratory & Address :	ALPHA TEST HOUSE 487/25, Near Prachin Shiv Mandir, Peeragarhi, New Delhi-110087		
Any Other Information	--

Sample / Report No. ELD3170052021 Sample Type Pressure Transducer Page 2 of 5

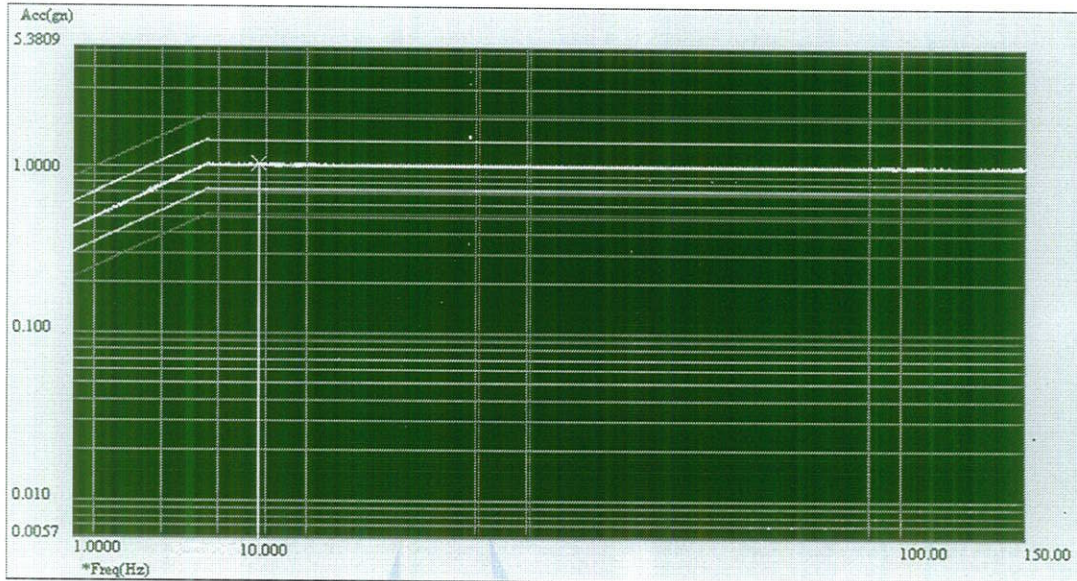
**Sine vibration test profile**

Sr. No.	Clause No.	Parameter & Test Conditions	Test Requirement	Measured/ Values/ Observations	Remark										
1.	Sine Vibration test ( IEC 60068-2-6)	Freq. Range 10-150Hz, 10m/s <sup>2</sup> (1g <sub>n</sub> ), 3 axes, sweep rate 1 octave/min 1 sweep/axis	Visual examination	No visual damage observed	Satisfactory										
2.	Random Vibration Test ( IEC 60068-2-64)	Duration: 5 Hours in each Orientation. Duration : 15Hours

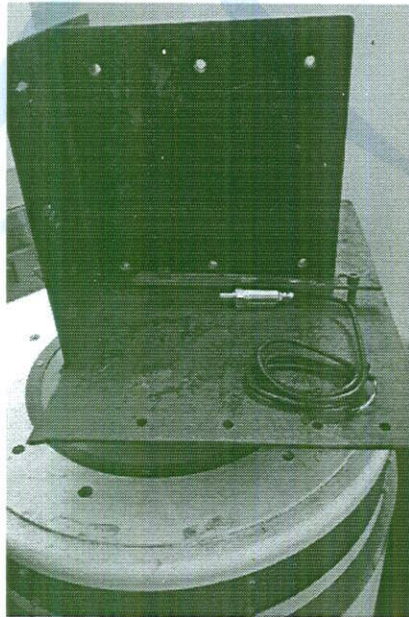
**Test set up X-Axis**

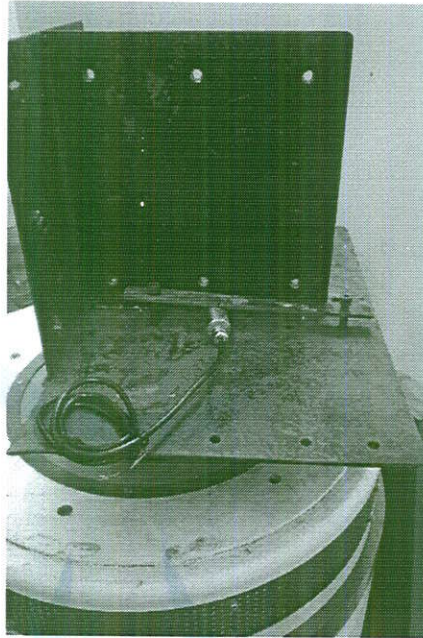
Test set up Y-Axis

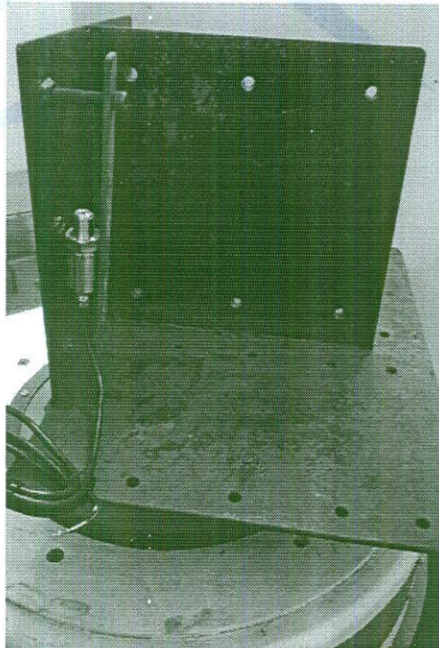
Test set up Z-Axis

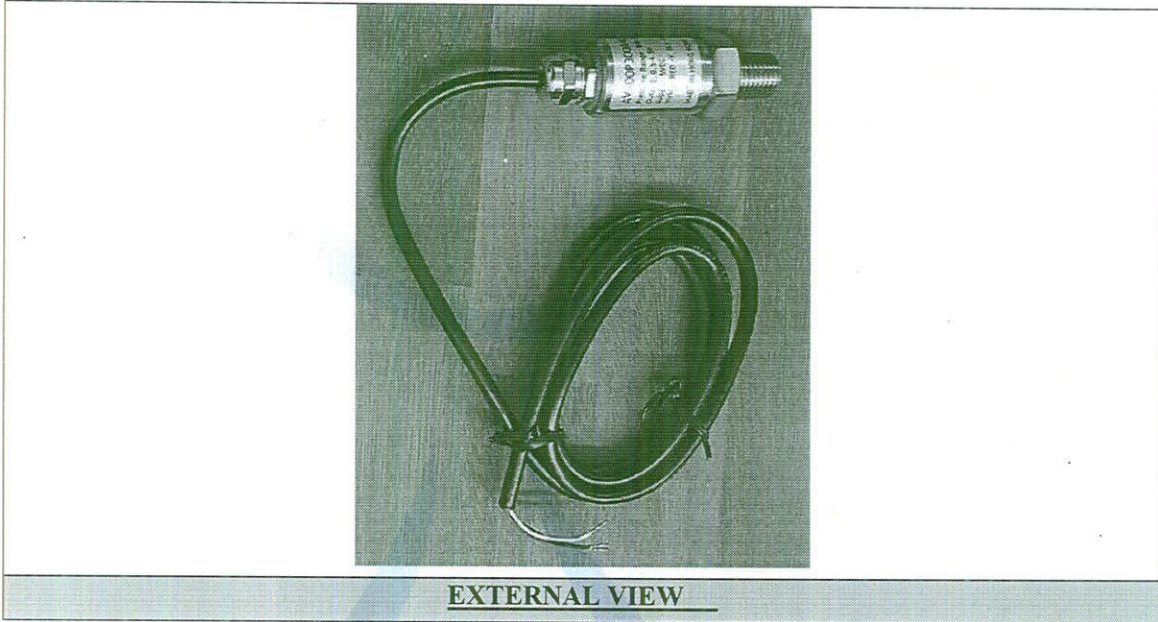
EXTERNAL VIEW
