## TEST REPORT

TEST REPORT			
Sample / Report No.	ELD3170092021	Page 1 of 5	
Name and Address of Customer	Avery Instrument Unit 8, 23/F, Laurels Industrial Centre, 32 Tai Yau Street, San Po Kong, Kowloon, Hong Kong		
Product Description	Pressure Transducer		
Sample Qty.	01	Date of Receipt	13/11/2021
Model Number	AV901P010GNL4X206	Start Date of Analysis	13/11/2021
Name of Manufacturer & Address:	Avery Instrument Unit 8, 23/F, Laurels Industrial Centre, 32 Tai Yau Street, San Po Kong, Kowloon, Hong Kong	End Date of Analysis	27/11/2021
Test Standard	Shock Test As Per IEC 60068-2-27, Sine Vibration Test as per IEC 60068-2-6, Random Vibration Test as per IEC 60068-2-64	Report Issue Date	29/11/2021
Sample received condition	<input checked="" type="checkbox"/> Good <input type="checkbox"/> Others		
Test laboratory & Address :	ALPHA TEST HOUSE 487/25, Near Prachin Shiv Mandir, Peeragarhi, New Delhi-110087		
Any Other Information	--

Sample / Report No. ELD3170092021 Sample Type Pressure Transducer Page 2 of 5

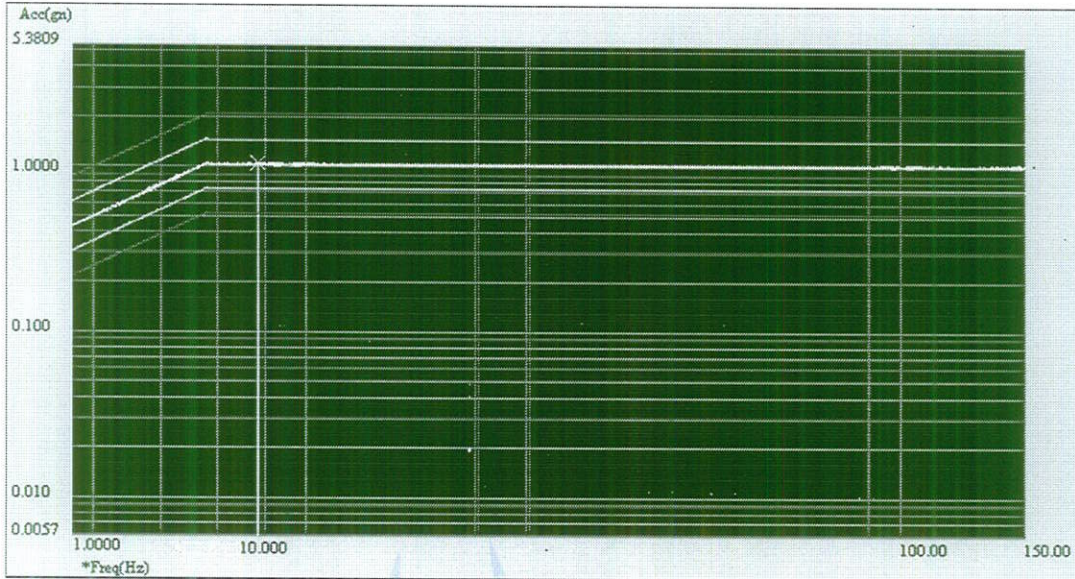
**Sine vibration test profile**

Sr. No.	Clause No.	Parameter & Test Conditions	Test Requirement	Measured/ Values/ Observations	Remark										
1.	Sine Vibration test ( IEC 60068-2-6)	Freq. Range 10-150Hz, 10m/s <sup>2</sup> (1g <sub>n</sub> ), 3 axes, sweep rate 1 octave/min 1 sweep/axis	Visual examination	No visual damage observed	Satisfactory										
2.	Random Vibration Test ( IEC 60068-2-64)	Duration: 5 Hours in each Orientation. Duration : 15Hours

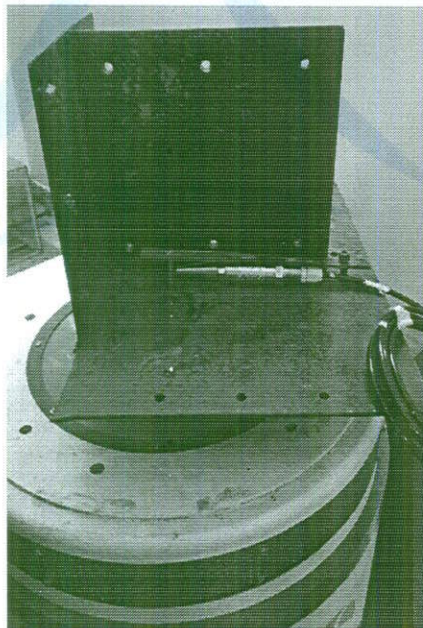
**Test set up X-Axis**

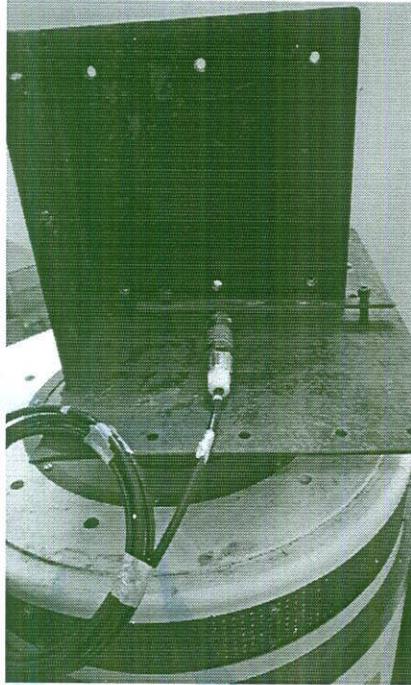
Test set up Y-Axis

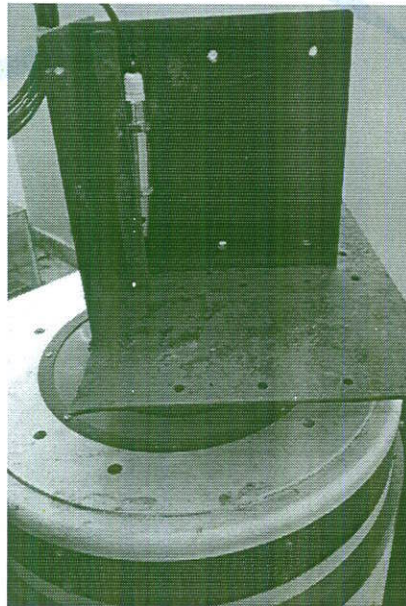
Test set up Z-Axis
